Client
Installation
Turbine
Foundation

Per Aarsleff A/S

Steel jacket with concrete transition piece,
concept design

OFFSHORE CASE STORY

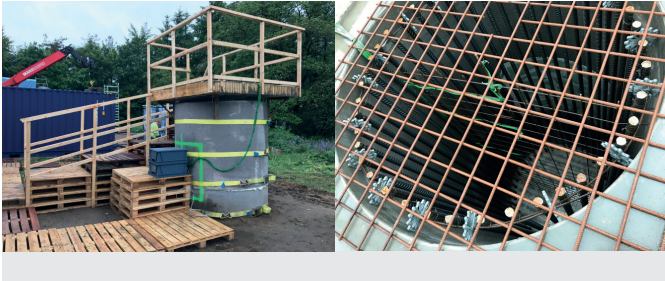
Grouting of base flange at pedestal in Poland

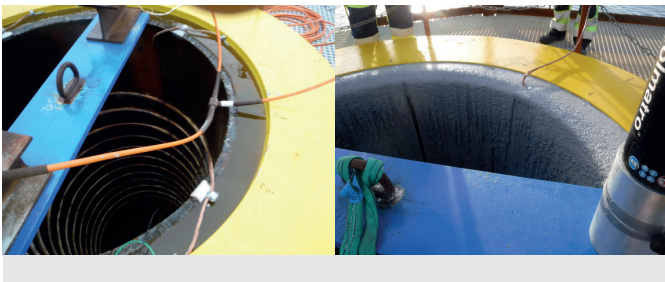
Grouting of joint between steel structure and concrete transition piece (TP) - Offshore at Nissum Bredning

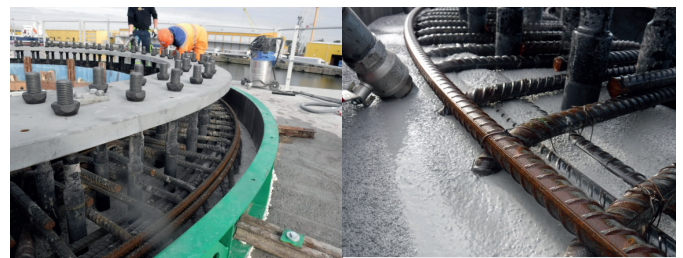
Grouting of pile-sleeve in steel structure - Offshore at Nissum Bredning

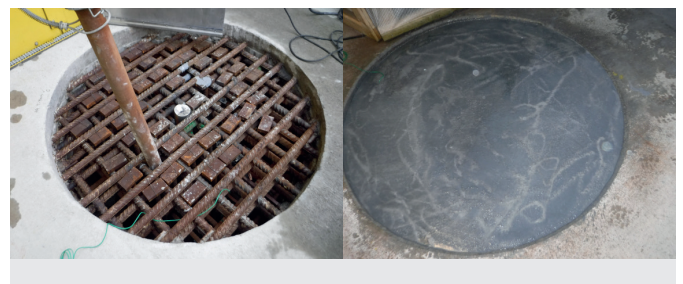
Sealing of pedestrian area and tower pedestal

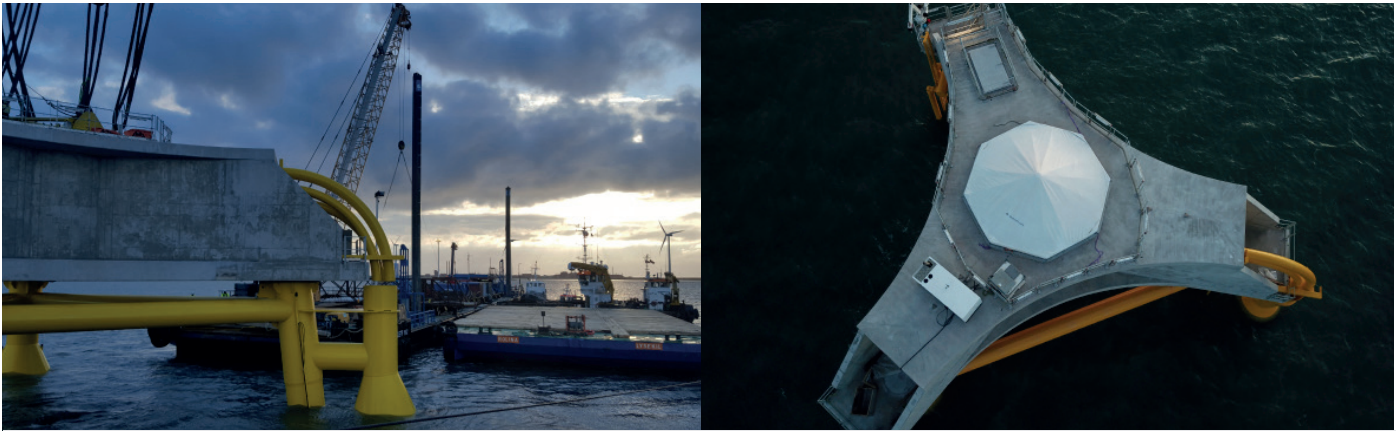
3-legged jacket with concrete transition piece

This innovative project, with a concrete TP mounted onto a 3-legged jacket foundation, had multiple disciplines of both grouting and sealing work including a mock-up test prior to the acceptance of the installation procedure. The mock-up test was to demonstrate the heat development in a full-scale concrete TP joint.
